ERIEVILLE RESERVOIR DAM

MADISON COUNTY, NEW YORK

INVENTORY NO. N.Y. 369

**PHASE I INSPECTION REPORT
NATIONAL DAM SAFETY PROGRAM**

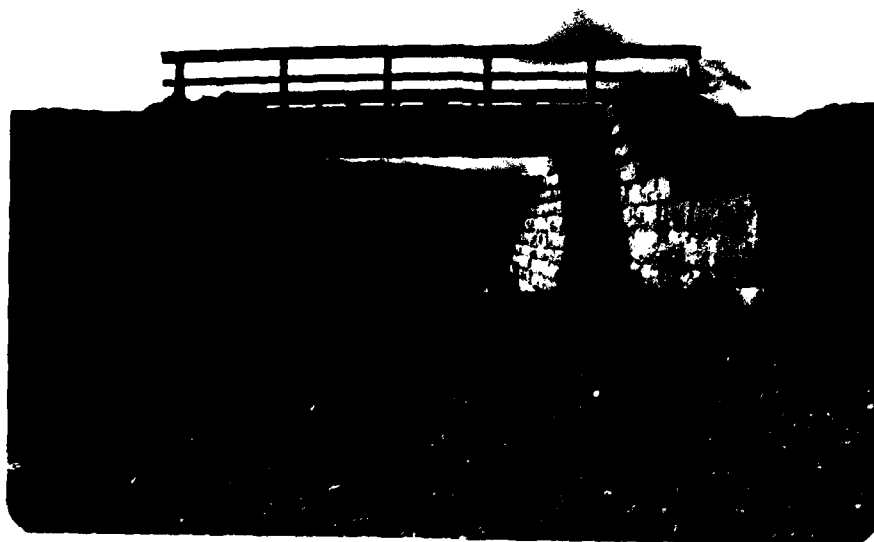
Crest of Auxiliary Spillway - Note Opening in Center with Provisions for Stop Logs

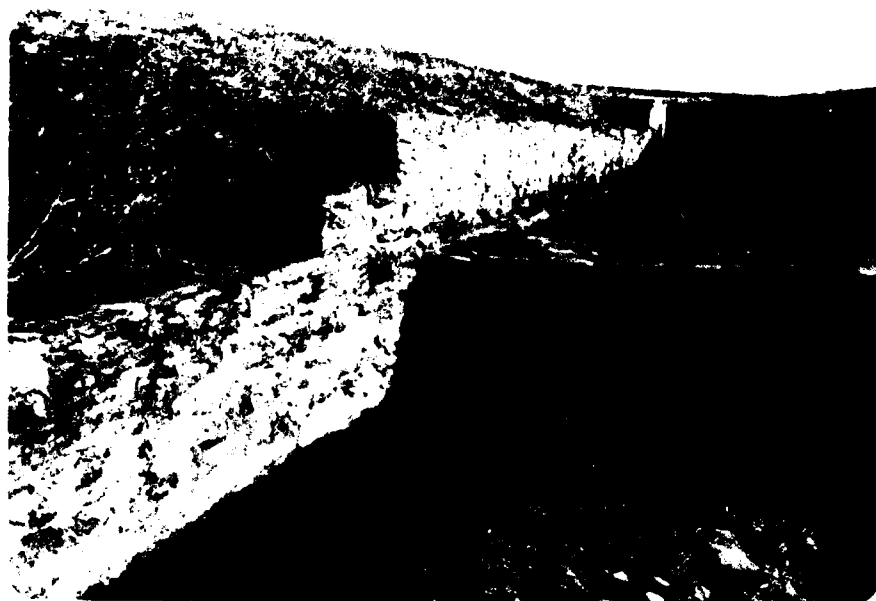
in good condition. There was a step in the spillway approximately midway down the slope. The outlet of a pipe which was apparently some type of drain was located at the base of this step. This pipe was flowing at a rate of approximately 5 gallons per minute. Another drain pipe outleted through the southwestern side wall of the channel. Flow in this pipe was slightly less than the flow in the other pipe. In addition to these pipes, there was a moderate flow coming through the northern channel wall, slightly downstream of the point where the drain pipes outlet.

Drainage Pipe Outletting into Auxiliary Spillway Channel
